**Flood Control Project Maintenance  
Levee Inspections**

**Maintenance Issue Types Only, Levee Inspection Report By Mile - Fall 2018**

**Reclamation District No. 1000 Natomas**

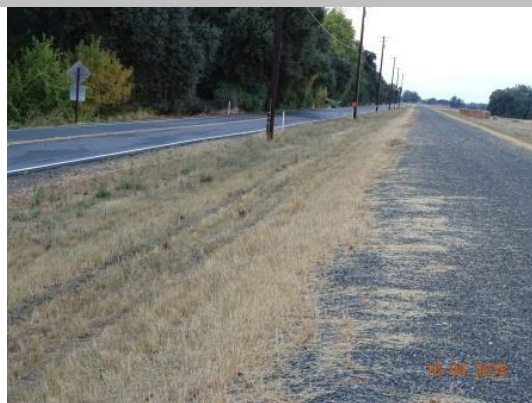
Photo 1 of 1 : FA\_2018\_RD1000\_31\_6\_20181022\_00048.jpg

LM Start	0.00	Rating **	A	Issue No.	6
LM End	11.94	Issue Type +	Ma	Location *	WS
Category	Earthen Levee			GPS Latitude/Longitude	
				Start	End
Item	Vegetation			38.780453 °	38.649883 °
				-121.603402 °	-121.577773 °
DWR ID	DWR_RD1000_01_f_2018_6				
Comment Code					
V1 : Control annual grass and weeds on the levee slopes and easements.					
Inspector Comment					
Annual Vegetation is well maintained, Fall 2018.

View looking upstream waterside of the well maintained vegetation, Fall 2018.

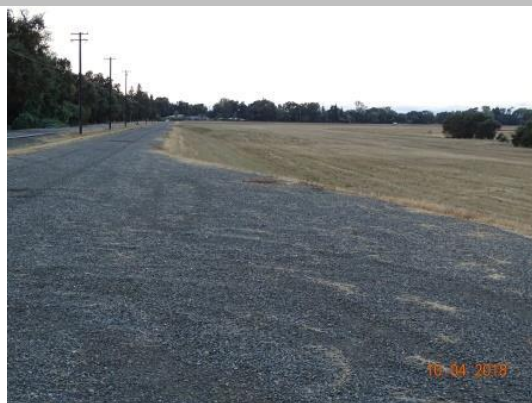
Photo 1 of 1 : FA\_2018\_RD1000\_31\_3\_20181022\_00047.jpg

LM Start	0.00	Rating **	A	Issue No.	3
LM End	11.94	Issue Type +	Ma	Location *	LS
Category	Earthen Levee			GPS Latitude/Longitude	
				Start	End
Item	Vegetation			38.780453 °	38.649883 °
				-121.603402 °	-121.577772 °
DWR ID	DWR_RD1000_01_f_2018_3				
Comment Code					
V1 : Control annual grass and weeds on the levee slopes and easements.					
Inspector Comment					
Annual Vegetation is well maintained, Fall 2018.

View looking upstream landside of the well maintained vegetation, Fall 2018.

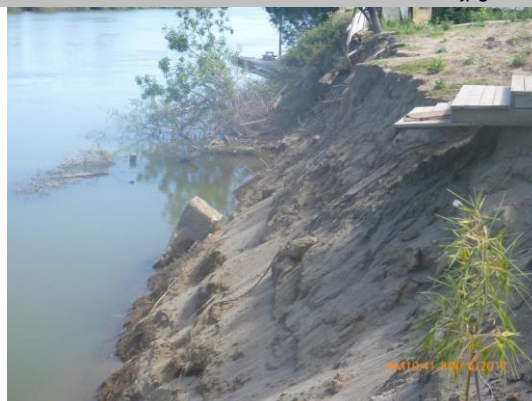
Photo 3 of 3 : LEVAL\_FA\_2018\_45\_1261.jpg

LM Start	<b>5.21</b>	Rating **	A/W	Issue No.	<b>4 (cont)</b>
LM End	<b>5.21</b>	Issue Type +	Ma	Location *	
Category	Supplemental			GPS Latitude/Longitude	
				Start	End
Item	2017 Storm Damage			38.710830°	38.710830°
				-121.611100°	-121.611100°
DWR ID	DWR_RD1000_01_f_2017_4				
Comment Code					
Inspector Comment					
Levee Evaluation Comments					
Description:					
Site ID No:45					
Site Designation:LMA-12					
Repair Type: Erosion					
Rating:Area of Concern					
Field Date:6/6/2017					
Notes: private residence

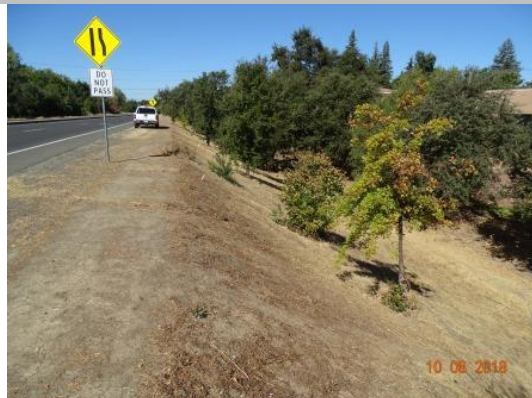
Photo 1 of 1 : FA\_2018\_RD1000\_32\_1\_20181108\_00006.jpg

LM Start	0.00	Rating **	A	Issue No.	1
LM End	2.31	Issue Type +	Ma	Location *	LS
Category	Earthen Levee			GPS Latitude/Longitude	
				Start	End
Item	Vegetation			38.603971°	38.605807°
				-121.510868°	-121.470672°
DWR ID	DWR_RD1000_02_f_2018_1				
Comment Code					
V1 : Control annual grass and weeds on the levee slopes and easements.					
Inspector Comment					
The annual vegetation is well maintained, Fall 2018.

View looking downstream Landside of the well maintained annual Vegetation, Fall 2018.

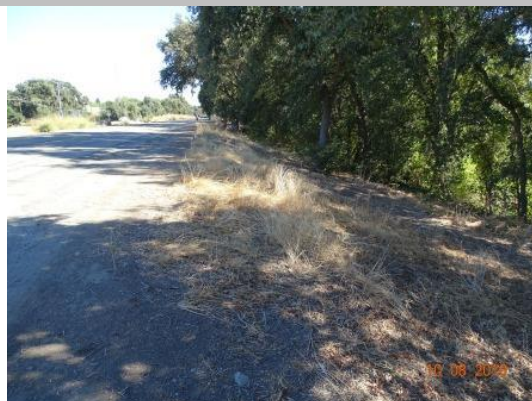
Photo 1 of 1 : FA\_2018\_RD1000\_32\_2\_20181108\_00007.jpg

LM Start	0.01	Rating **	A	Issue No.	2
LM End	2.31	Issue Type +	Ma	Location *	WS
Category	Earthen Levee			GPS Latitude/Longitude	
				Start	End
Item	Vegetation			38.604057 °	38.605807 °
				-121.510719 °	-121.470672 °
DWR ID	DWR_RD1000_02_f_2018_2				
Comment Code					
V1 : Control annual grass and weeds on the levee slopes and easements.					
Inspector Comment					
The annual vegetation is well maintained, Fall 2018.

View looking downstream waterside of the well maintained annual Vegetation, Fall 2018.

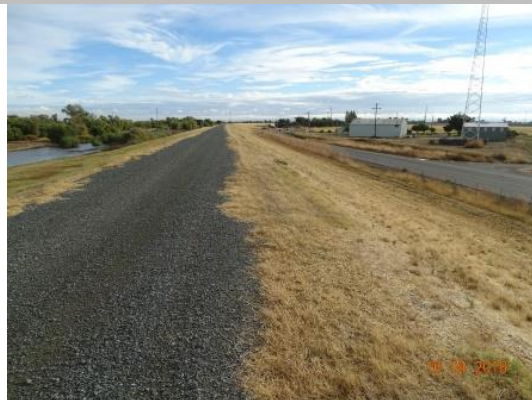
Photo 1 of 1 : FA\_2018\_RD1000\_33\_6\_20181108\_00014.jpg

LM Start	0.03	Rating **	A	Issue No.	6
LM End	16.83	Issue Type +	Ma	Location *	LS
Category	Earthen Levee			GPS Latitude/Longitude	
				Start	End
Item	Vegetation			38.606254 °	38.821603 °
				-121.470197 °	-121.542329 °
DWR ID	DWR_RD1000_03_f_2018_6				
Comment Code					
V1 : Control annual grass and weeds on the levee slopes and easements.					
Inspector Comment					
The annual vegetation is well maintained, Fall 2018.

View looking downstream landside of the well maintained annual vegetation, Fall 2018.

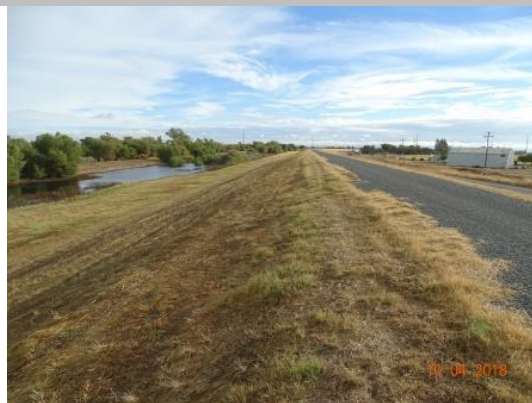
Photo 1 of 1 : FA\_2018\_RD1000\_33\_11\_20181108\_00015.jpg

LM Start	0.03	Rating **	A	Issue No.	11
LM End	16.83	Issue Type +	Ma	Location *	WS
Category	Earthen Levee			GPS Latitude/Longitude	
				Start	End
Item	Vegetation			38.606254 °	38.821603 °
				-121.470197 °	-121.542330 °
DWR ID	DWR_RD1000_03_f_2018_11				
Comment Code					
V1 : Control annual grass and weeds on the levee slopes and easements.					
Inspector Comment					
The annual vegetation is well maintained, Fall 2018.

View looking downstream waterside of the well maintained annual vegetation, Fall 2018.

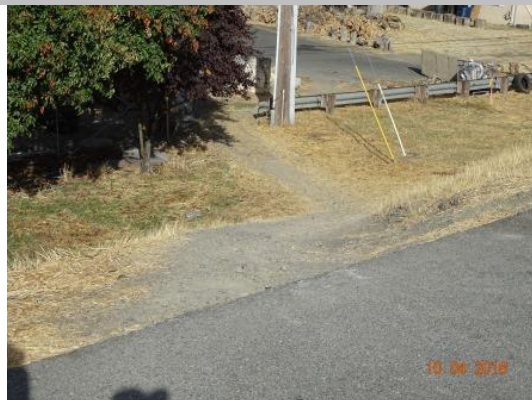
Photo 1 of 1 : FA\_2018\_RD1000\_33\_14\_20181108\_00017.jpg

LM Start	1.93	Rating **	M	Issue No.	14
LM End	1.93	Issue Type +	Ma	Location *	LS
Category	Earthen Levee			GPS Latitude/Longitude	
				Start	End
Item	Slope Stability			38.633110 °	38.633110 °
				-121.471868 °	-121.471868 °
DWR ID	DWR_RD1000_03_f_2018_14				
Comment Code					
S2 : Repair the levee slope damaged by foot traffic and prevent access where possible.					
Inspector Comment					
Rut caused by foot traffic should be repaired, Fall 2018.

View looking down the landside levee slope at a rut created by foot traffic, Fall 2018.

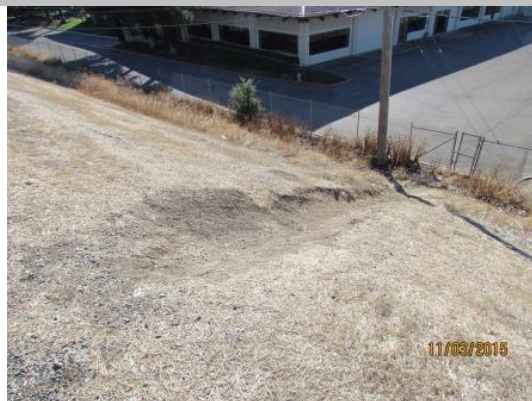
Photo 1 of 1 : FA\_2018\_RD1000\_33\_15\_20180918\_00011.jpg

LM Start	2.36	Rating **	M	Issue No.	15
LM End	2.36	Issue Type +	Ma	Location *	LS
Category	Earthen Levee			GPS Latitude/Longitude	
				Start	End
Item	Slope Stability			38.639326 °	38.639326 °
				-121.473107 °	-121.473107 °
DWR ID	DWR_RD1000_03_f_2015_15				
Comment Code					
S2 : Repair the levee slope damaged by foot traffic and prevent access where possible.					
Inspector Comment

View of the landside levee slope damaged by foot traffic.

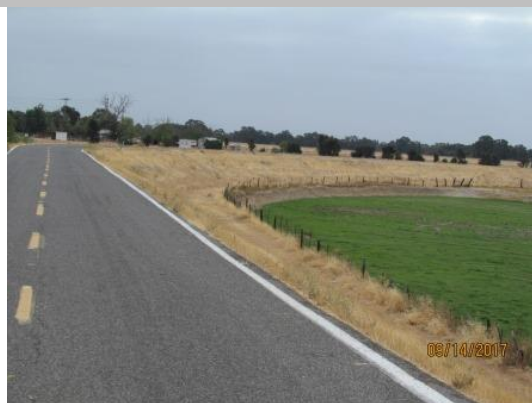
Photo 1 of 1 : FA\_2018\_RD1000\_33\_1\_20180918\_00001.jpg

LM Start	4.78	Rating **	A/W	Issue No.	1
LM End	4.89	Issue Type +	Ma	Location *	LS
Category	Earthen Levee			GPS Latitude/Longitude	
				Start	End
Item	Animal Control			38.672913 °	38.673685 °
				-121.481364 °	-121.483115 °
DWR ID	DWR_RD1000_03_f_2013_1				
Comment Code					
A3 : No rodents visible, but rodent burrows visible; need to backfill and compact or grout burrows.					
Inspector Comment					
Several bait traps line the levee toe, no sign of rodents, Fall 2018.

View taken facing the landside looking downstream at location where there was rodent activity in past years. Rodent holes have been filled and no new activity was observed. Several bait traps at landside levee toe. Fall 2017.

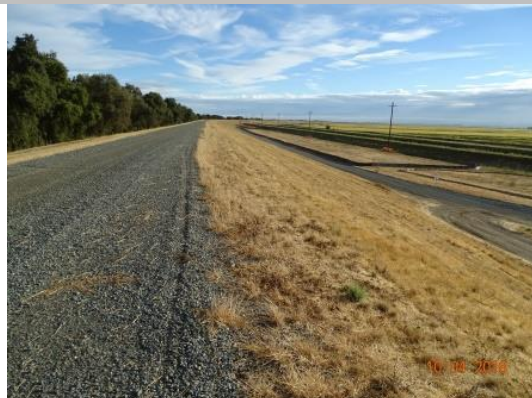
Photo 1 of 1 : FA\_2018\_RD1000\_34\_13\_20181108\_00002.jpg

LM Start	0.07	Rating **	A	Issue No.	13
LM End	4.20	Issue Type +	Ma	Location *	LS
Category	Earthen Levee			GPS Latitude/Longitude	
				Start	End
Item	Vegetation			38.820092 °	38.781976 °
				-121.544880 °	-121.603185 °
DWR ID	DWR_RD1000_04_f_2018_13				
Comment Code					
V1 : Control annual grass and weeds on the levee slopes and easements.					
Inspector Comment					
The annual vegetation is well maintained, Fall 2018.

View looking upstream landside of the well maintained annual Vegetation, Fall 2018.

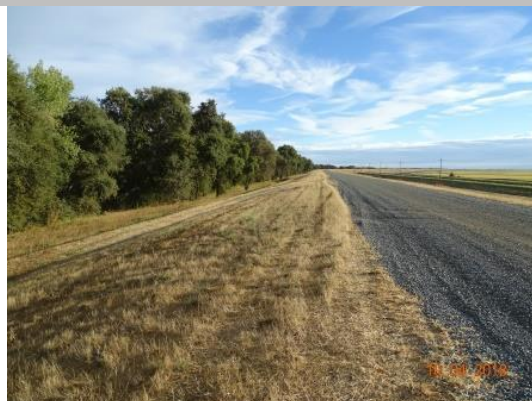
Photo 1 of 1 : FA\_2018\_RD1000\_34\_14\_20181108\_00001.jpg

LM Start	0.07	Rating **	A	Issue No.	14
LM End	4.20	Issue Type +	Ma	Location *	WS
Category	Earthen Levee			GPS Latitude/Longitude	
				Start	End
Item	Vegetation			38.820092 °	38.781976 °
				-121.544880 °	-121.603185 °
DWR ID	DWR_RD1000_04_f_2018_14				
Comment Code					
V1 : Control annual grass and weeds on the levee slopes and easements.					
Inspector Comment					
The annual vegetation is well maintained, Fall 2018.

View looking upstream waterside of the well maintained annual Vegetation, Fall 2018.
